AFFTC-TR-61-54
October 1961

**CATEGORY II YJ
AND J85-GE-5
ENGINE FOLLOW-ON
EVALUATIONS**

**AIR FORCE FLIGHT TEST CENTER
EDWARDS AIR FORCE BASE, CALIFORNIA
AIR FORCE SYSTEMS COMMAND
UNITED STATES AIR FORCE**

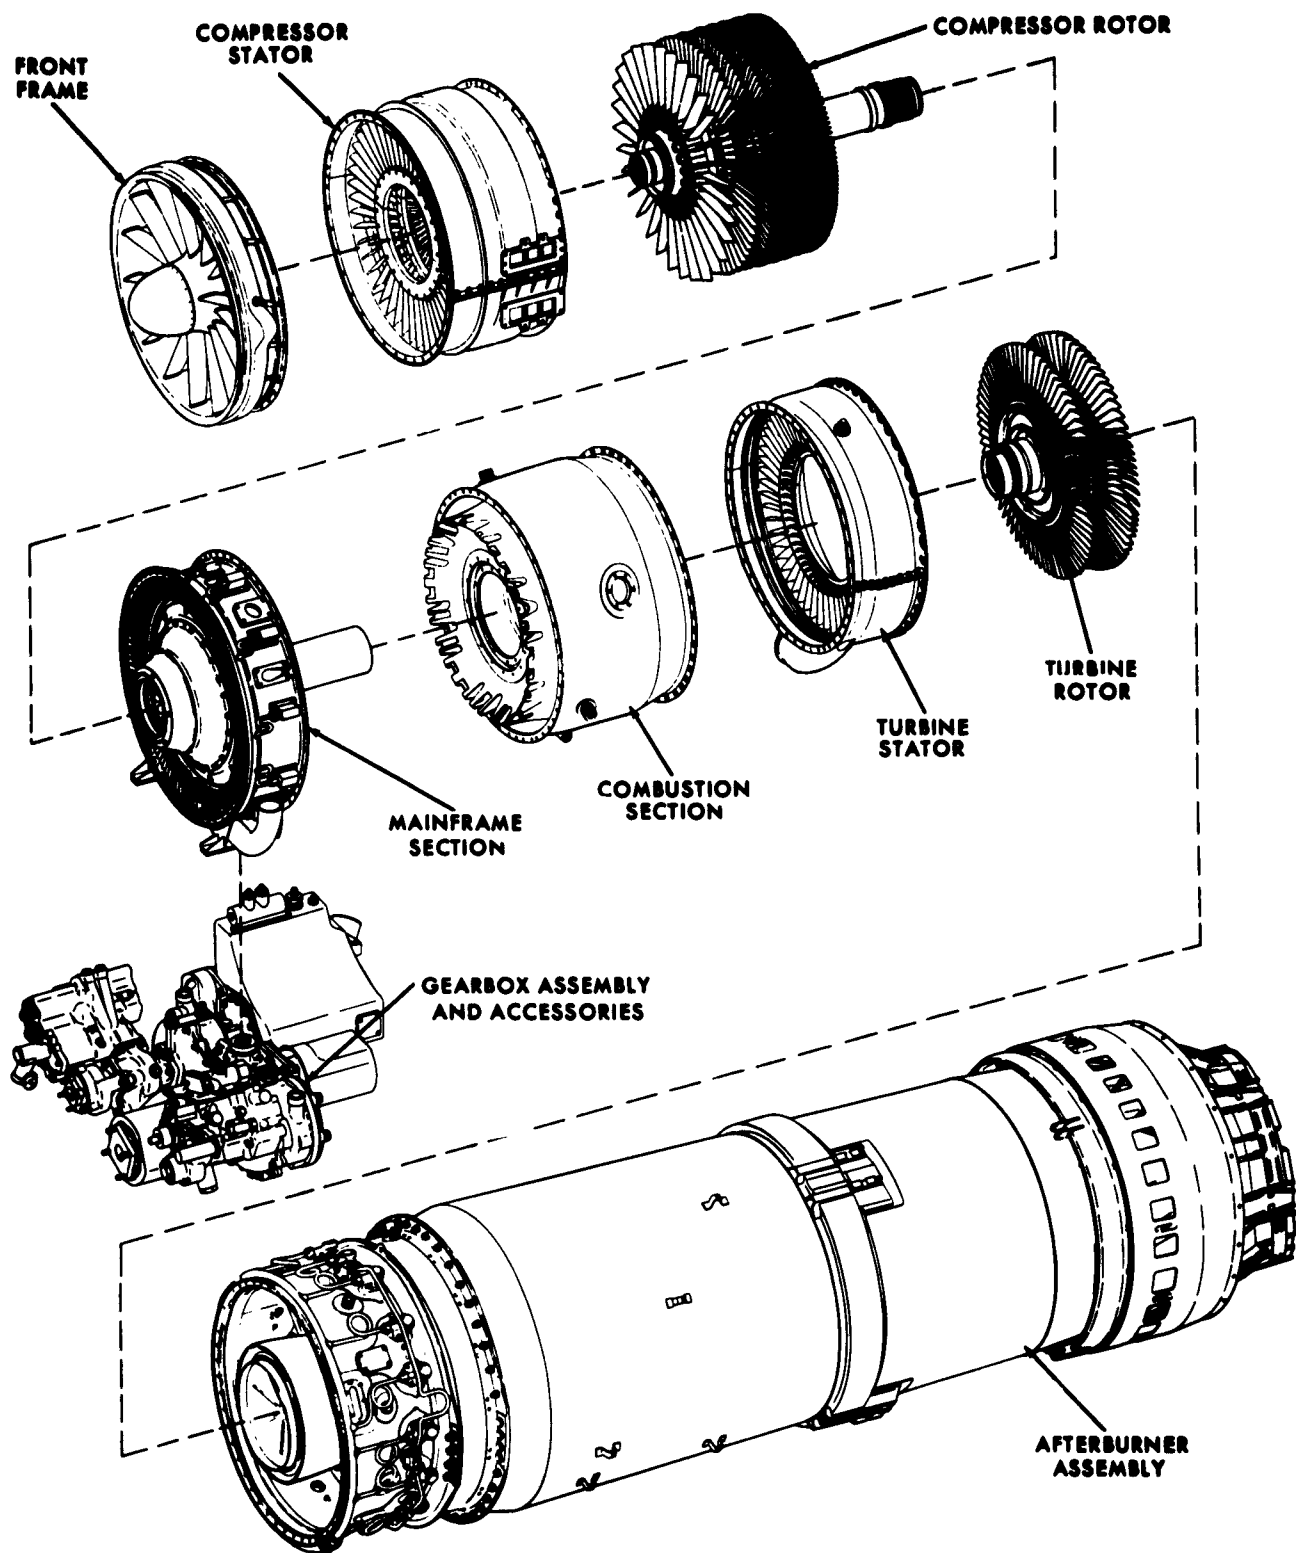
FIGURE 1

The J85-GE-5 engine has an eight-stage axial flow compressor, a through-flow annular combustion chamber, a two-stage turbine, an afterburner, and an infinitely variable iris-type converging exhaust nozzle. The major engine sections are shown in an exploded view in Figure 1. Estimated uninstalled

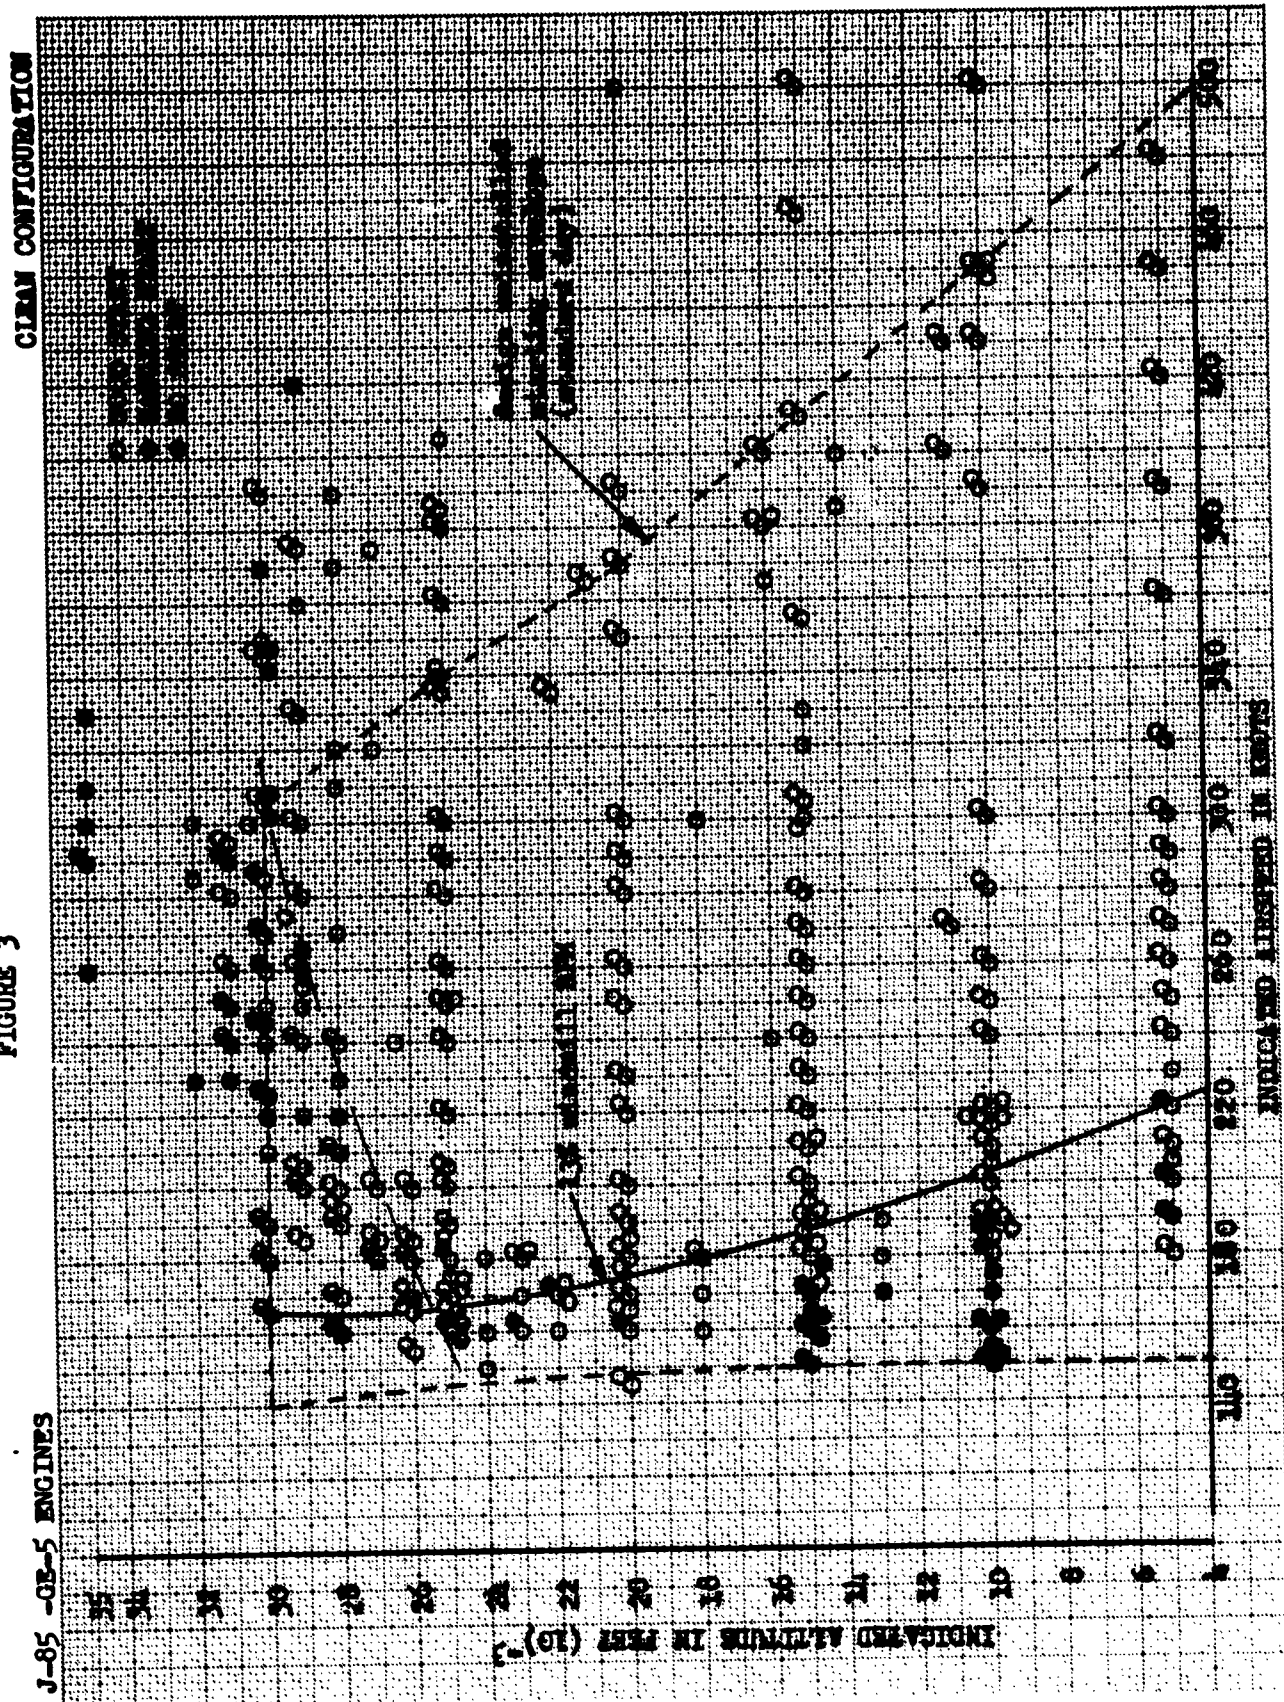
An inflight engine restart program was flown to define the altitude-airspeed envelope of successful air restart capability and was compared to the predicted contractor envelope. Four hundred airstarts were attempted at altitudes from 5,000 to 31,000 feet and airspeeds from 145 to 540 knots IAS. Figure 3 is a plot of airstarts showing range of conditions tested, super-imposed on the uninstalled engine airstart specification envelope. Near the low speed and high altitude edges of the envelope, many hanging starts were encountered and the probability of a good airstart was low. A

3. Engine airtasks were successful below 29,000 feet at 13 percent or higher windmill rpm. High-altitude, low air-speed starts may require more than 1 minute for completion. Using techniques outlined in this report, airtask reliability is extremely high in the envelope defined by Fig. 3.

T-38A AIRSTART ENVELOPE
FIGURE 3

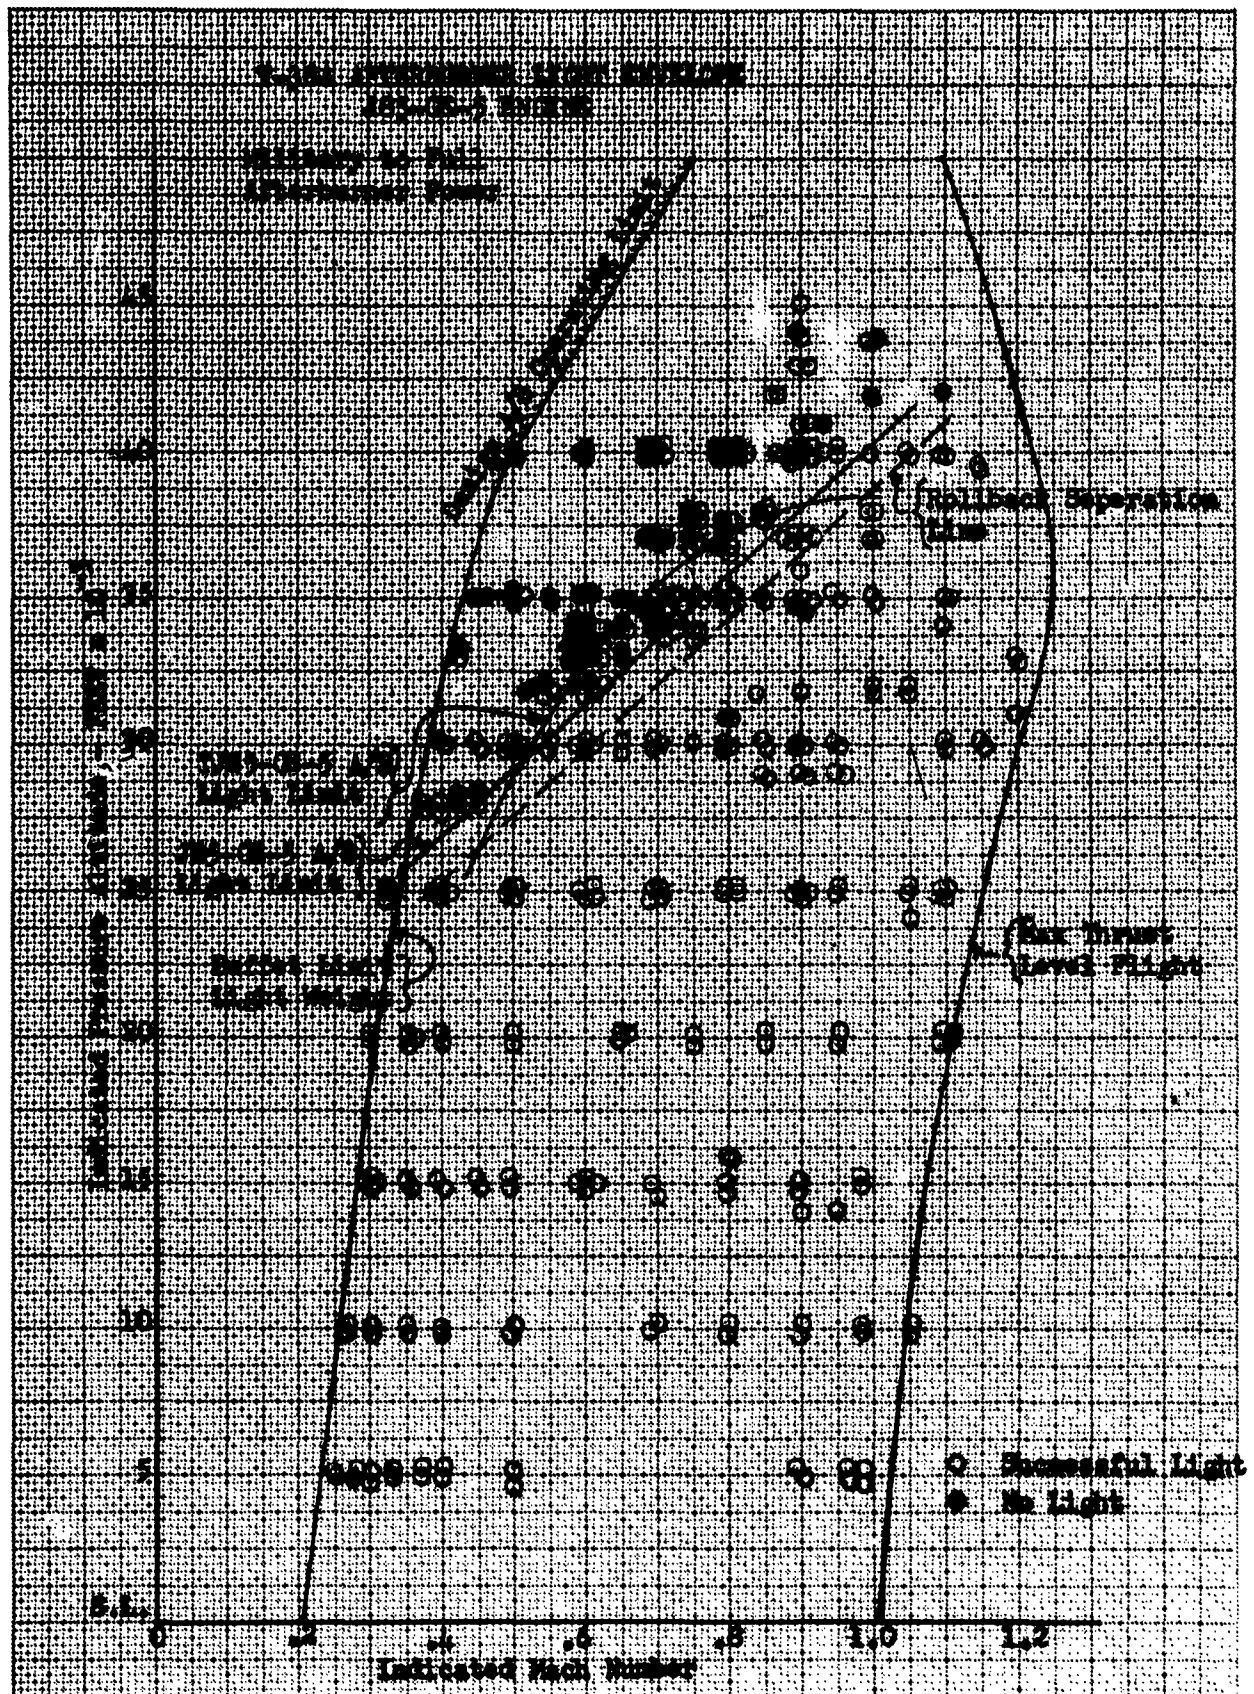
FIGURE 9

The most significant improvement of the "Nutcracker" program was the increase in the ceiling of the idle to afterburner light limit line. As can be seen on Fig. 9, the ceiling has been raised approximately 6,000 feet at an indicated Mach number (IMN) of .5, and approximately 10,000 feet at IMN of .9. The rpm rollback line determined by throttle bursts from military to full afterburner lies essentially along the same line. No afterburner blowouts during the climb or cruise at 50,000 feet were experienced by any of the pilots flying this demonstration. This improvement is considered operationally satisfactory at the current stage of engine development.

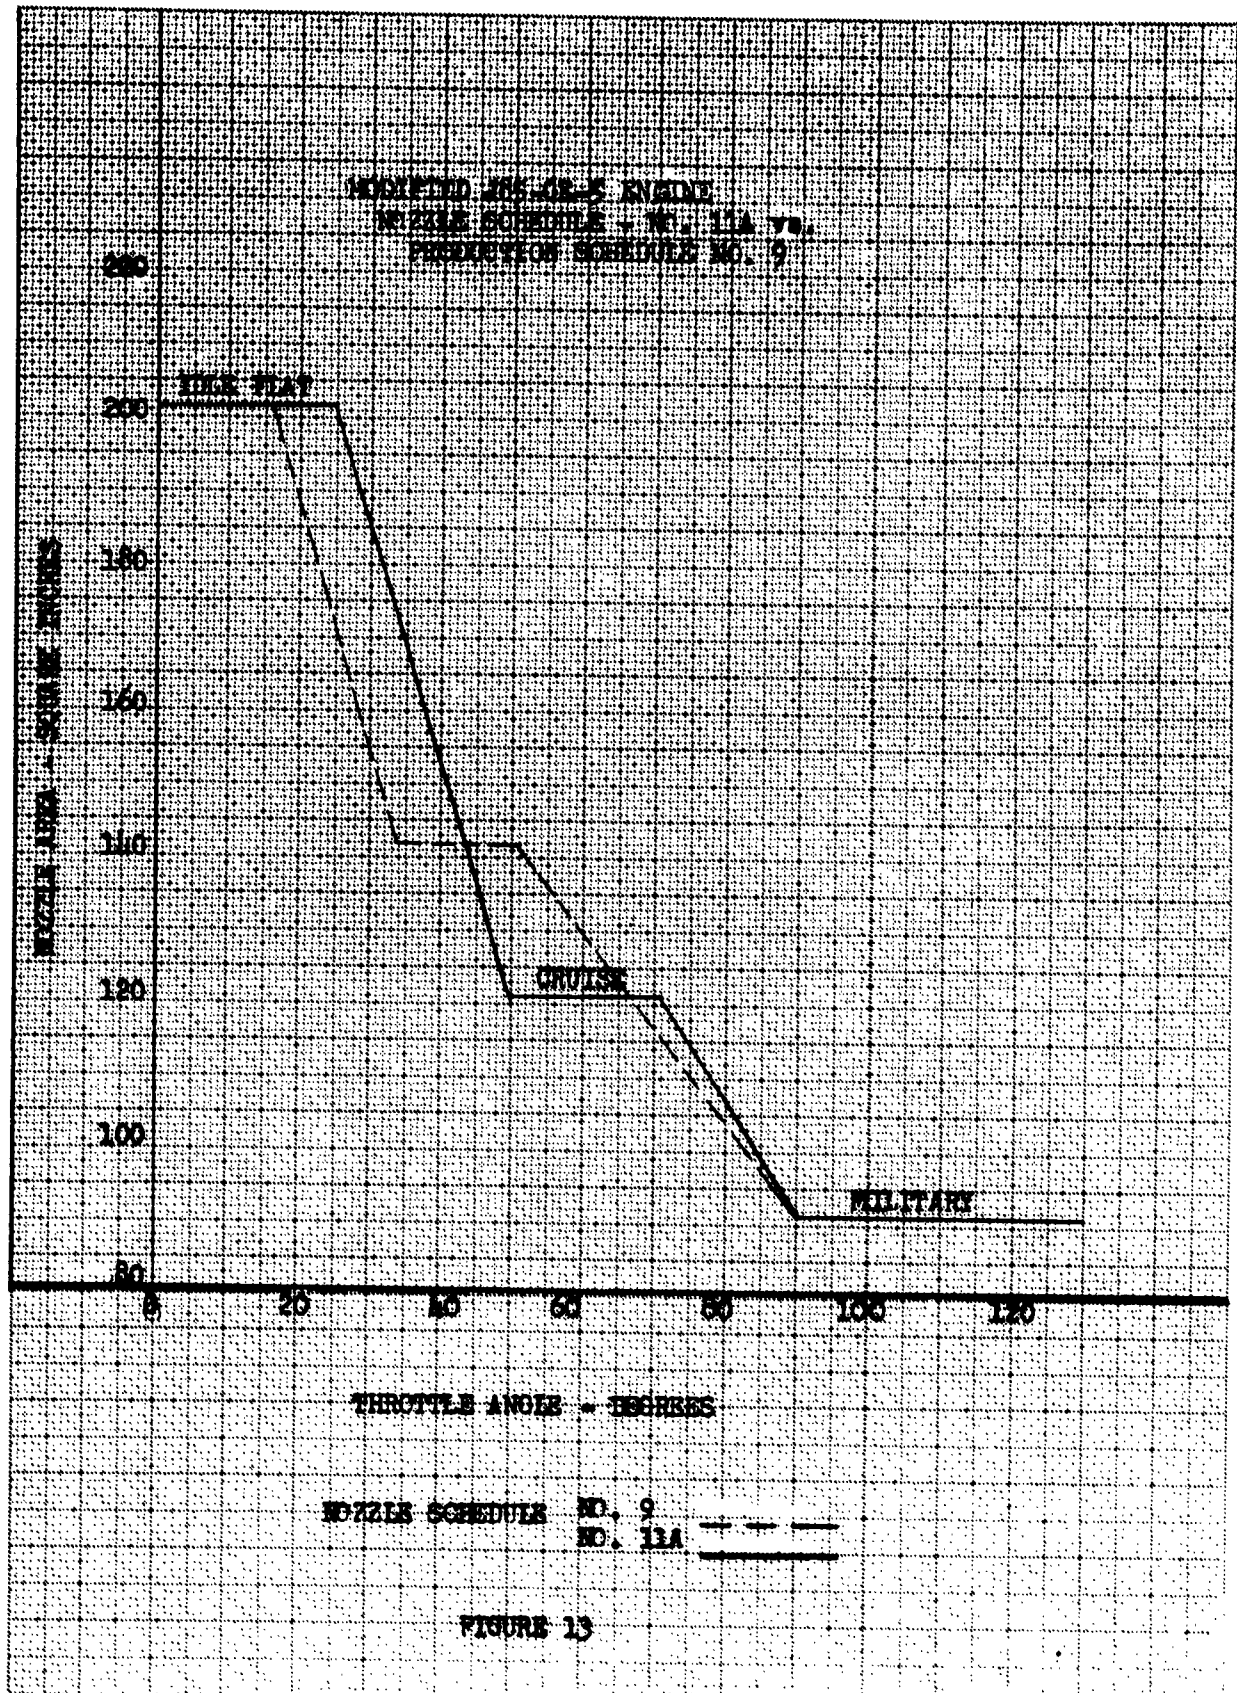
FIGURE 13

within the 91 to 96 percent rpm range at .9 IMN at 45,000 feet. Figure 13 compares the 11A schedule with No. 9 schedule, the current production item. (1b)
